TECHNICAL MEMORANDUM

To: Attorney Ashley Lehocky/Silton, Seifert, Carlson SC
From: David Ozsvath, PhD, PG/Sand Creek Consultants, Inc.
Pete Arntsen, MS, PH, PG/Sand Creek Consultants, Inc.
Referenced: Town of Greenville – Unnamed Navigable Stream and Reported Karst Structures
Subject: Geologic Field Investigations
Date: August 21, 2017

**Photolog of Geologic Exploration Pits
Greenville Karst Investigation
Town of Greenville, Wisconsin**

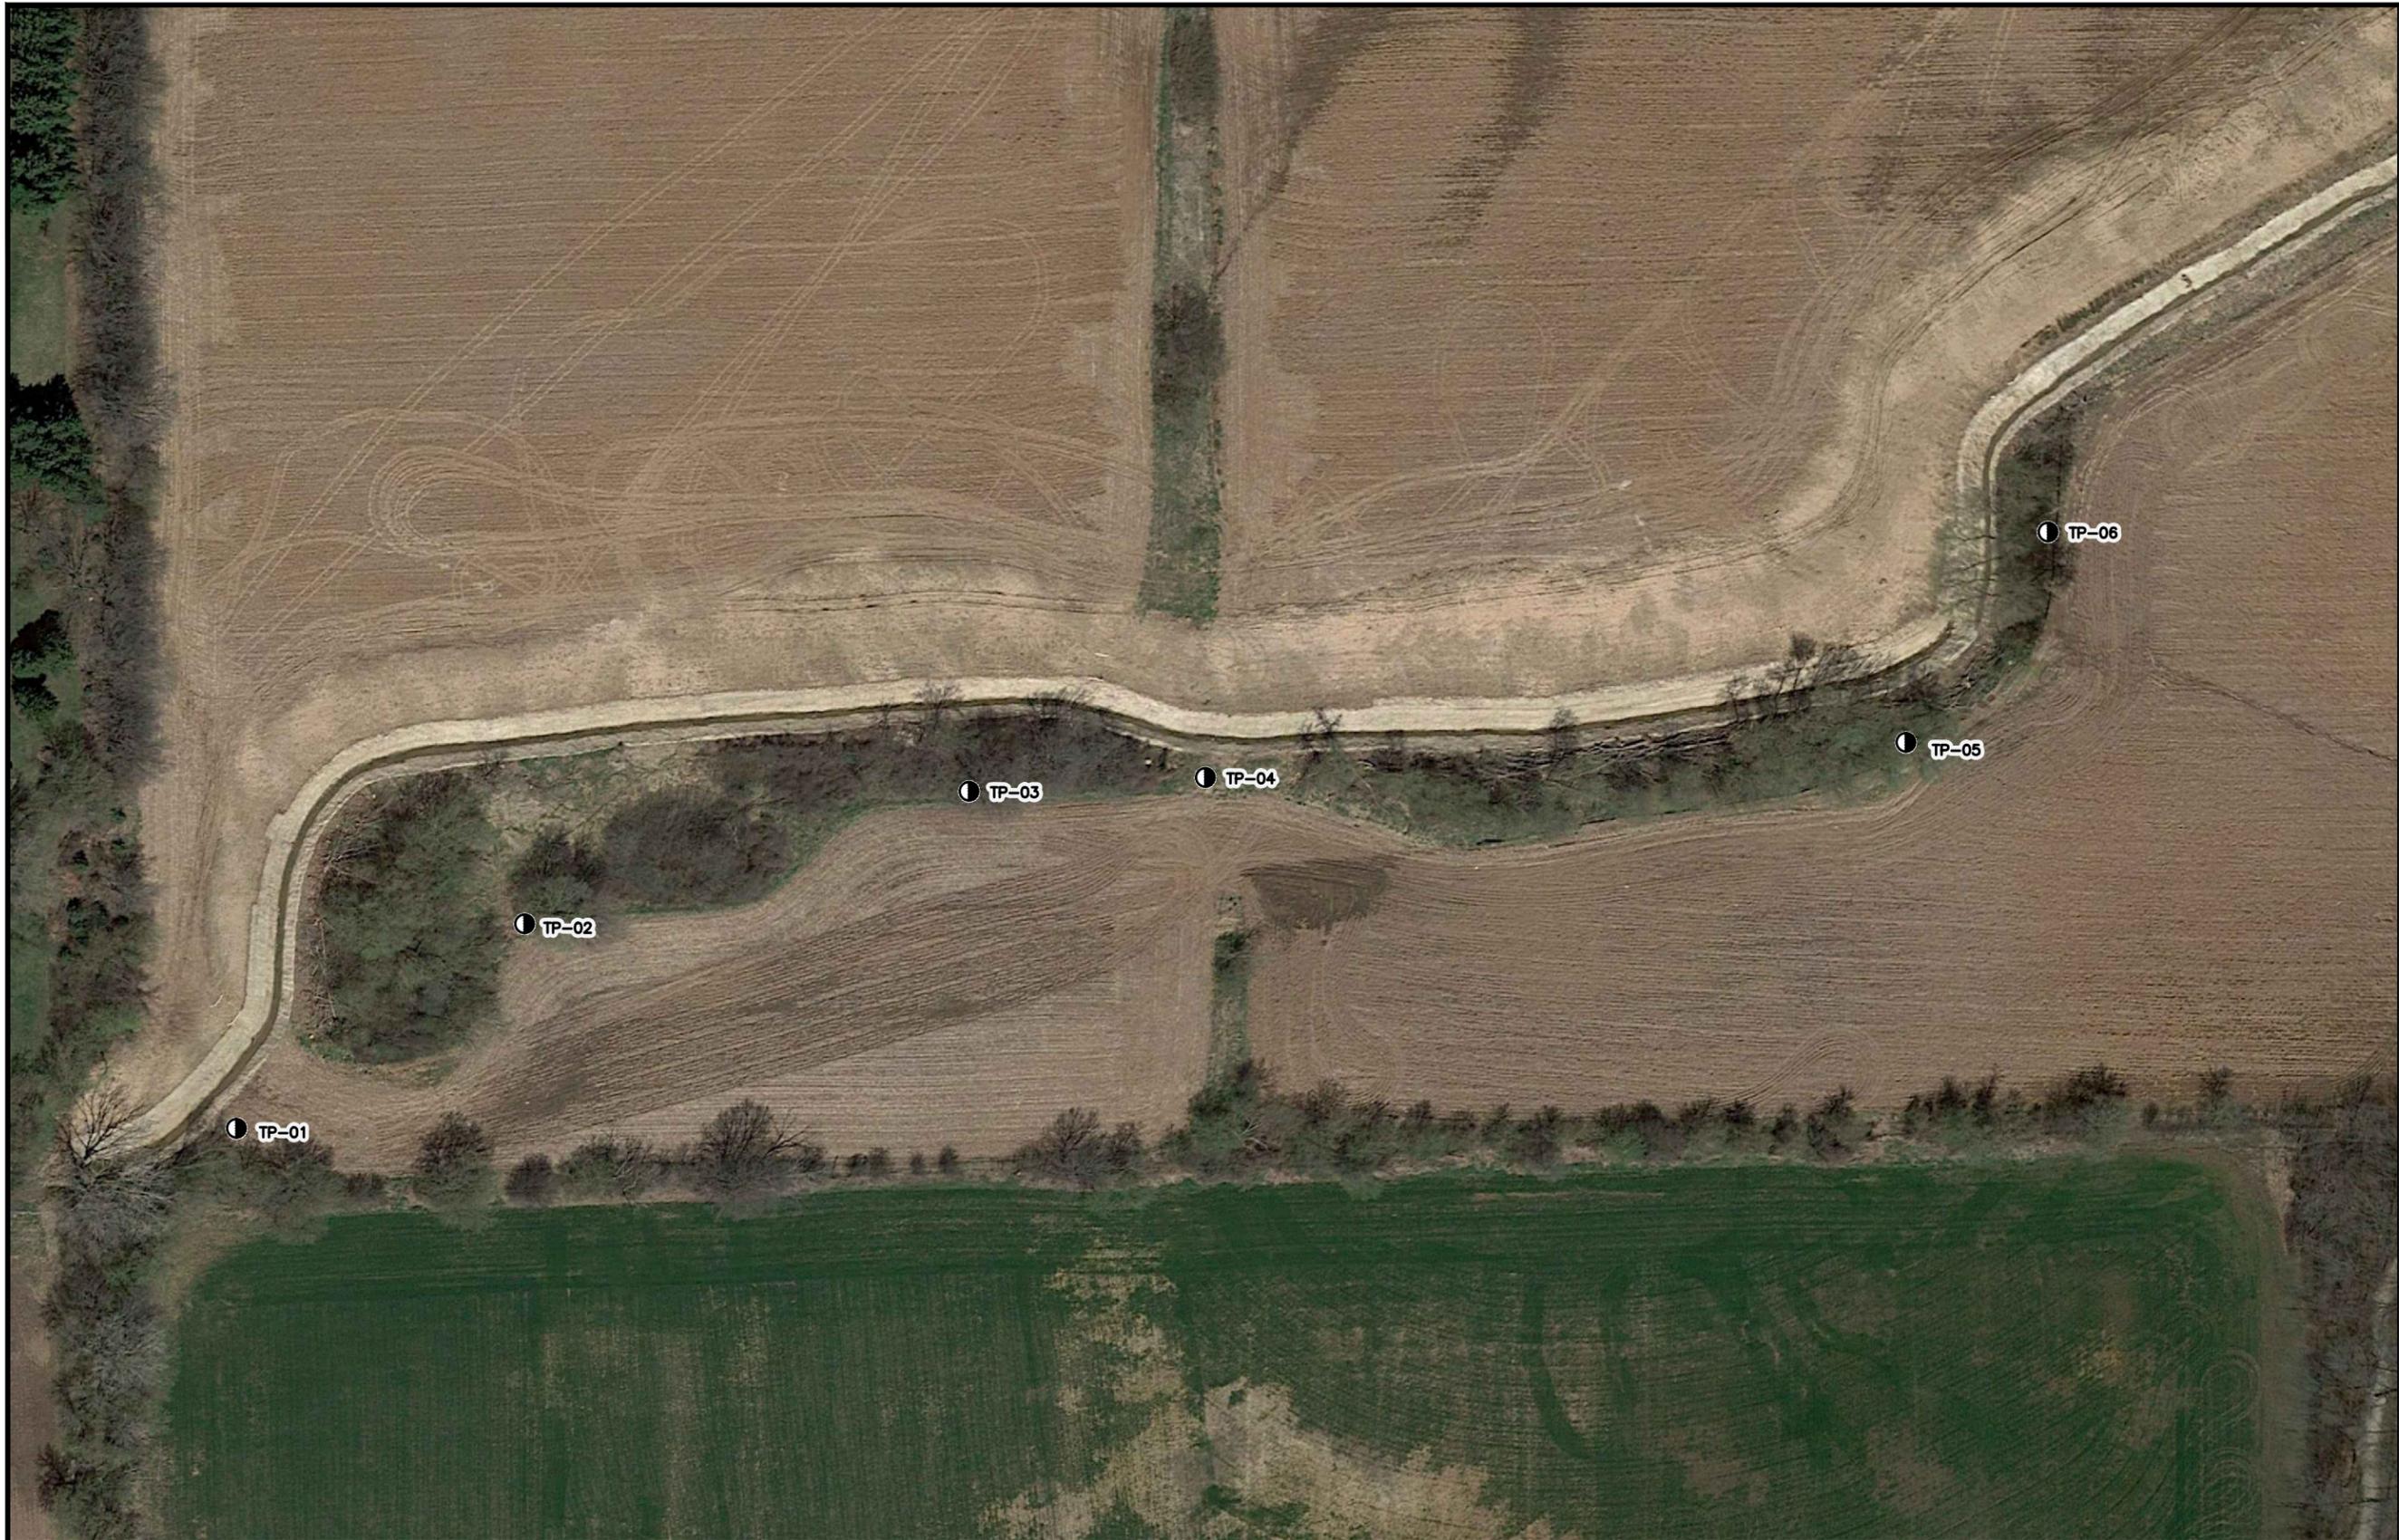
FIGURE 3

The locations of the six test pits are indicated on **Figure 3. Geologic logs** of the test pits and a **photolog** of the investigation are attached.

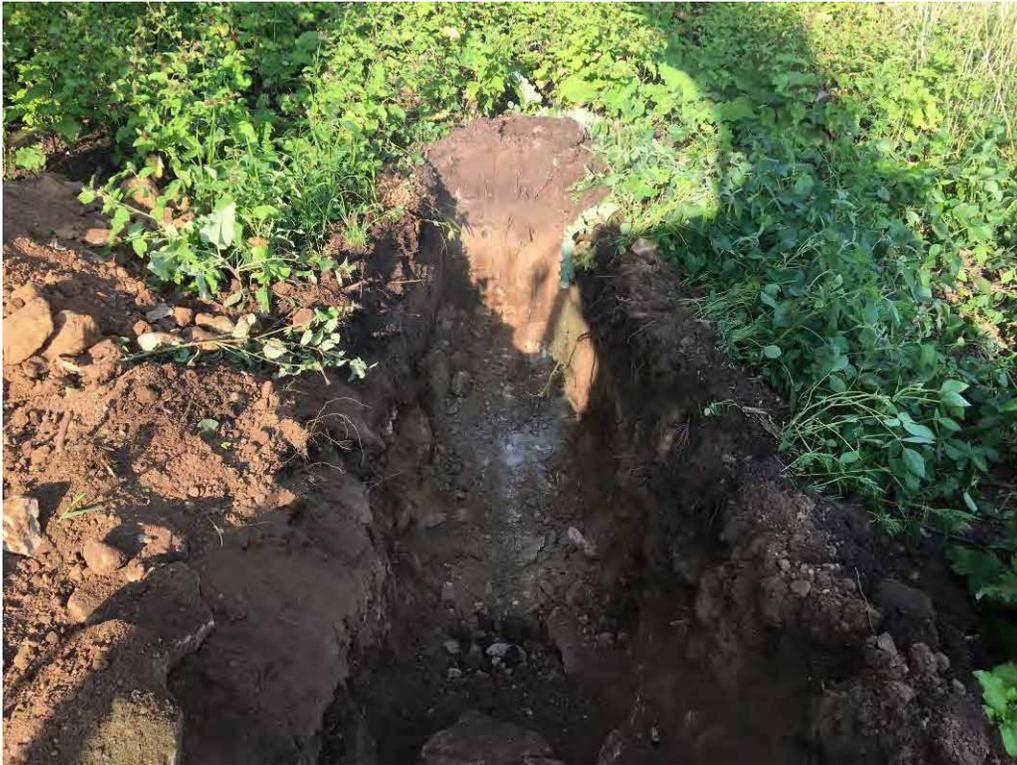
- TP-01: Topsoil, a dark grey silt loam (clayey, sandy silt), extended approximately 16 inches into the subsurface. The subsoil consisted of grey-brown silt loam, with clay coatings occurring at depth. Weathered dolostone was encountered at about 3.5 feet, and competent dolostone at about 5 feet.
- TP-02: Topsoil is the same as TP-01 to a depth of 10 inches. Subsoil is similar to TP-01 near the surface, but with an accumulation of sub-rounded to sub-angular gravel and cobbles at a depth of about 2 feet that was underlain by an uneven layer of yellow-brown clean, silty, very fine sand approximately 6 inches thick. Weathered dolostone was encountered at roughly 4 feet, and competent dolostone at about 6 feet.

Photo No. 7 TP-01 final depth approximately 5 feet

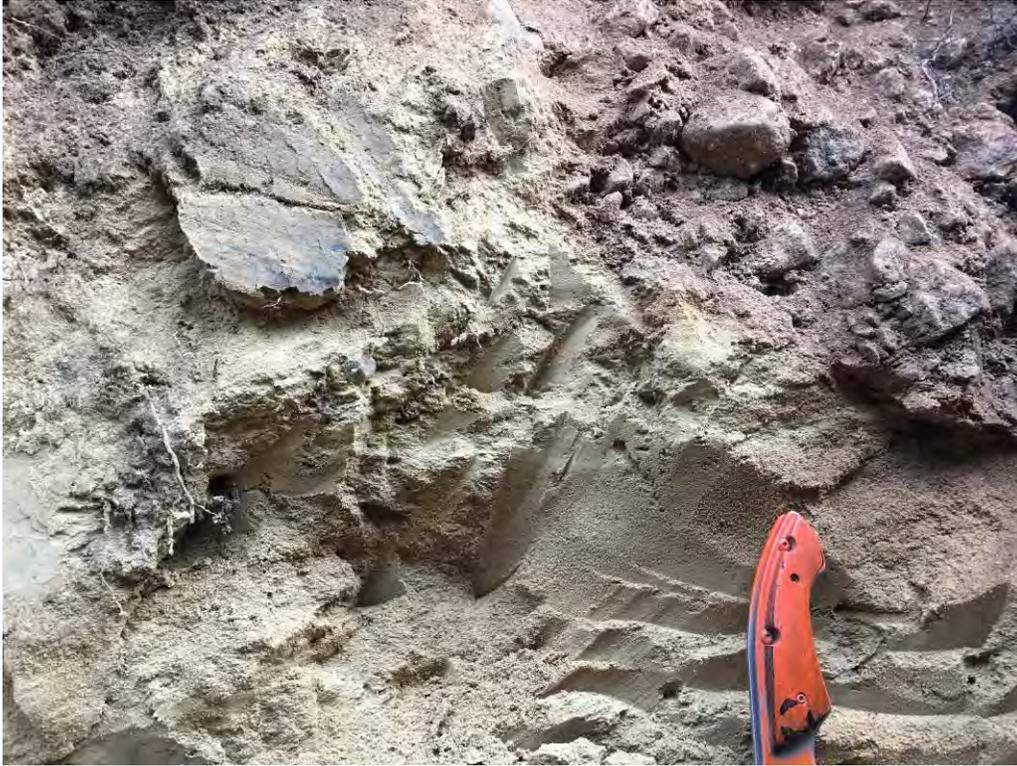
Photo No. 13 TP-02; layer of very fine sand

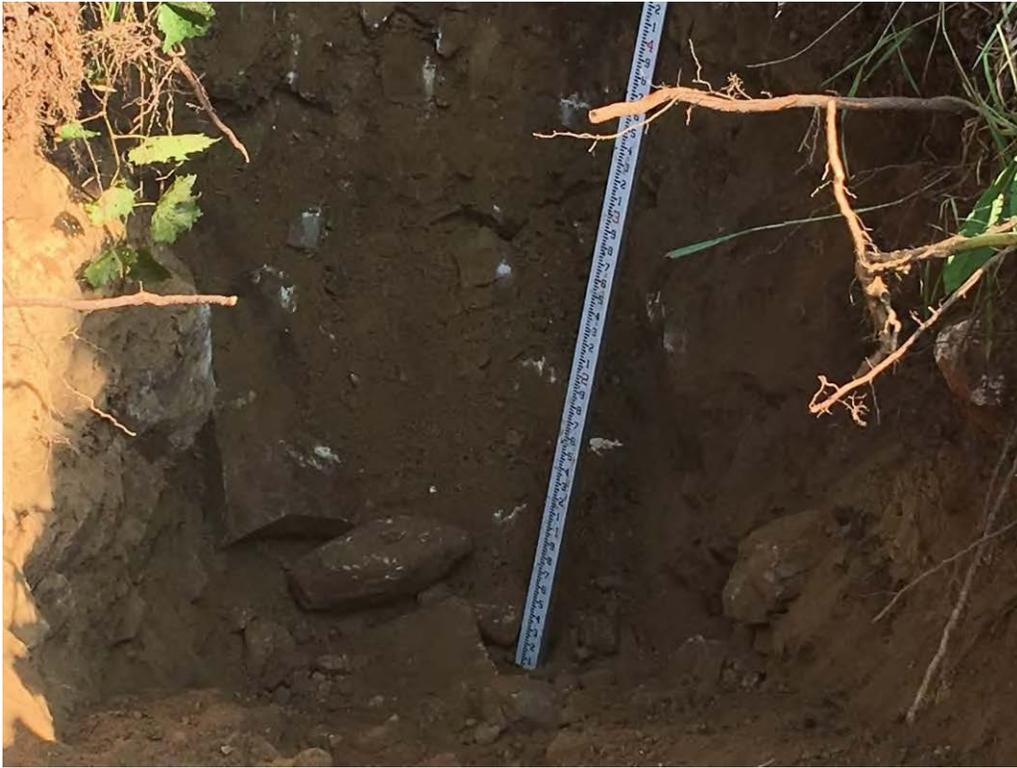
Photo No. 17 TP-02; base of excavation approximately 6 feet

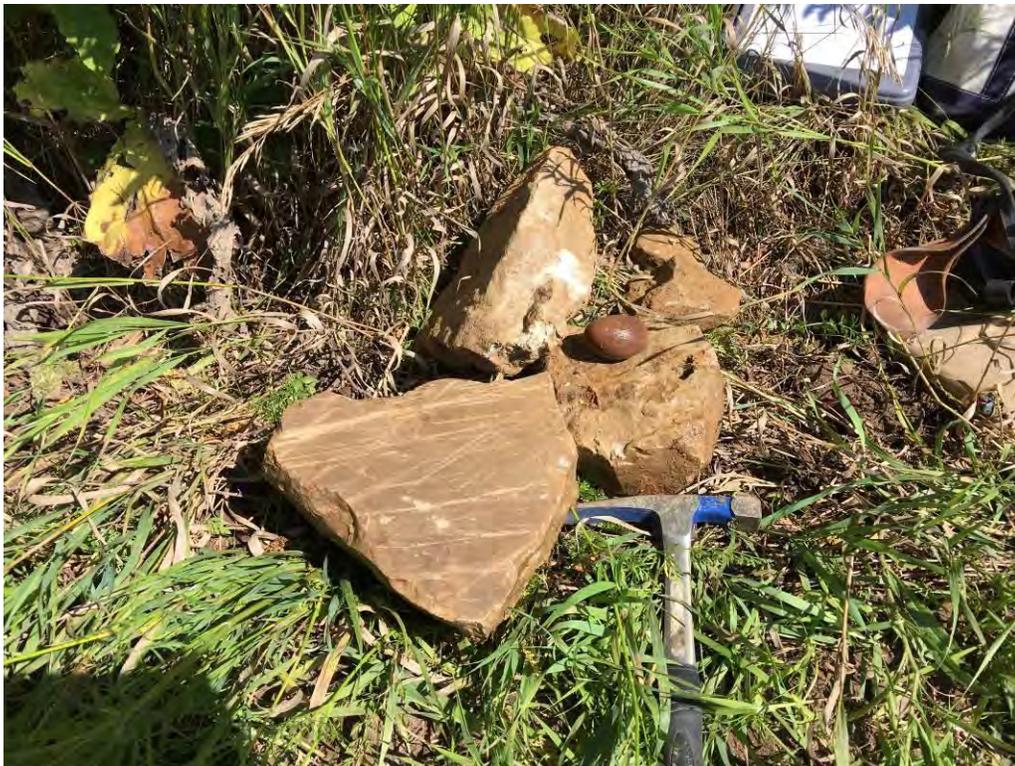
- TP-03: Topsoil is the same to a depth of 14 inches. The subsoil has a higher clay content, and sub-rounded to sub-angular gravel and cobbles appear at around 3 feet. The profile then grades to a brown loamy sand, followed by silty, very fine sand above the rock. Weathered dolostone was encountered at about 6.5 feet, and competent dolostone at about 8.5 feet. In addition to the blocks and flagstones, rock fragments removed from TP-03 included one block with a highly polished surface, one with a drusey vug (a void containing small (calcite?) crystals), another with a chalk-filled vug, and a smooth, egg-sized cobble that appeared to have been rounded by water transport (see Photo No. 22).

Each of the test pits except for TP-01 encountered horizons where the materials exhibited characteristics of sediments that have been transported and deposited by flowing water (e.g., the silty, very fine sand layers). Although the smooth, egg-sized cobble found in TP-03 suggests considerable rounding by fluvial processes, most of the sediment included in this category reflects only minimal

Photo No. 22 TP-03; rock samples

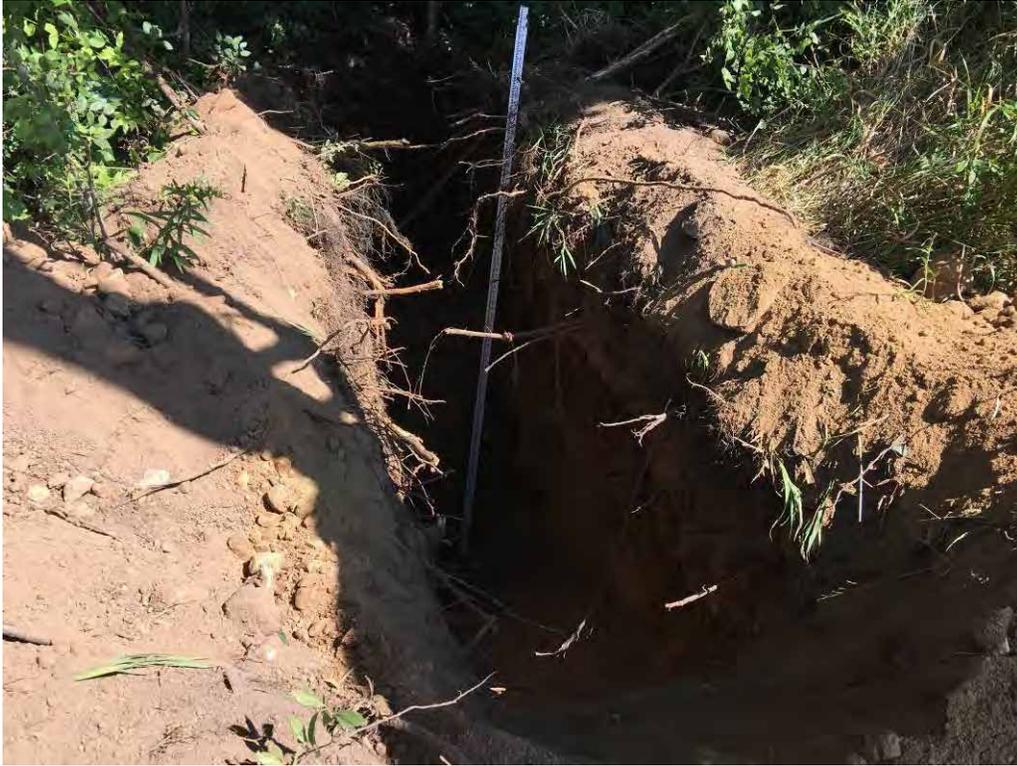
Photo No. 23 TP-03; maximum depth approximately 8.5 feet

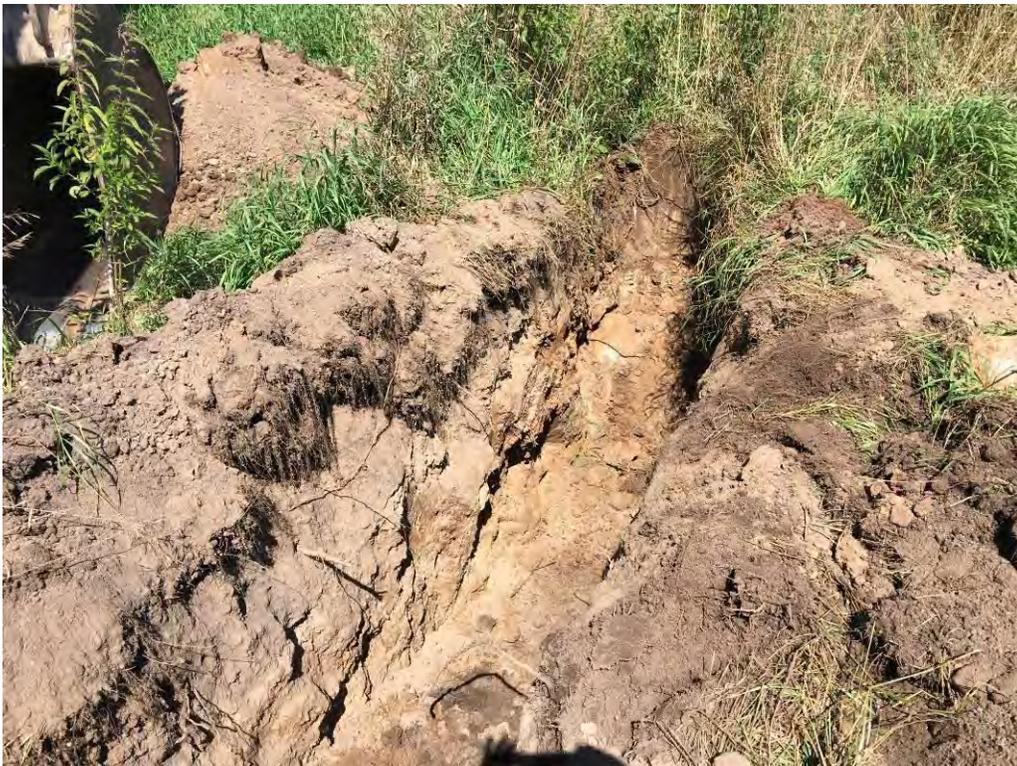
- TP-04: This was the location of a hole of uncertain origin about 1 foot deep with lateral side passages less than a foot long. Topsoil is the same to a depth of 12 inches. The upper subsoil included a 1.5-foot thick layer of sandy loam with gravel and small cobbles. Beneath this layer, the coarse fraction decreased and clay fraction increased, ending in a layer of mottled reddish-brown clay loam at around 4 feet. This deeper subsoil included what appeared to be a boulder that was weathered to near total disintegration, as evidenced by the dark sand particles that were easily scraped off but could not be chipped off. Beneath the clay loam and “boulder,” the material was a brown sandy loam that graded to a gravelly, cobbly, silty, very fine sand atop rock. Weathered dolostone was encountered at about 8 feet, and competent dolostone at about 10 feet.

Photo No. 26 TP-04; shallow pit

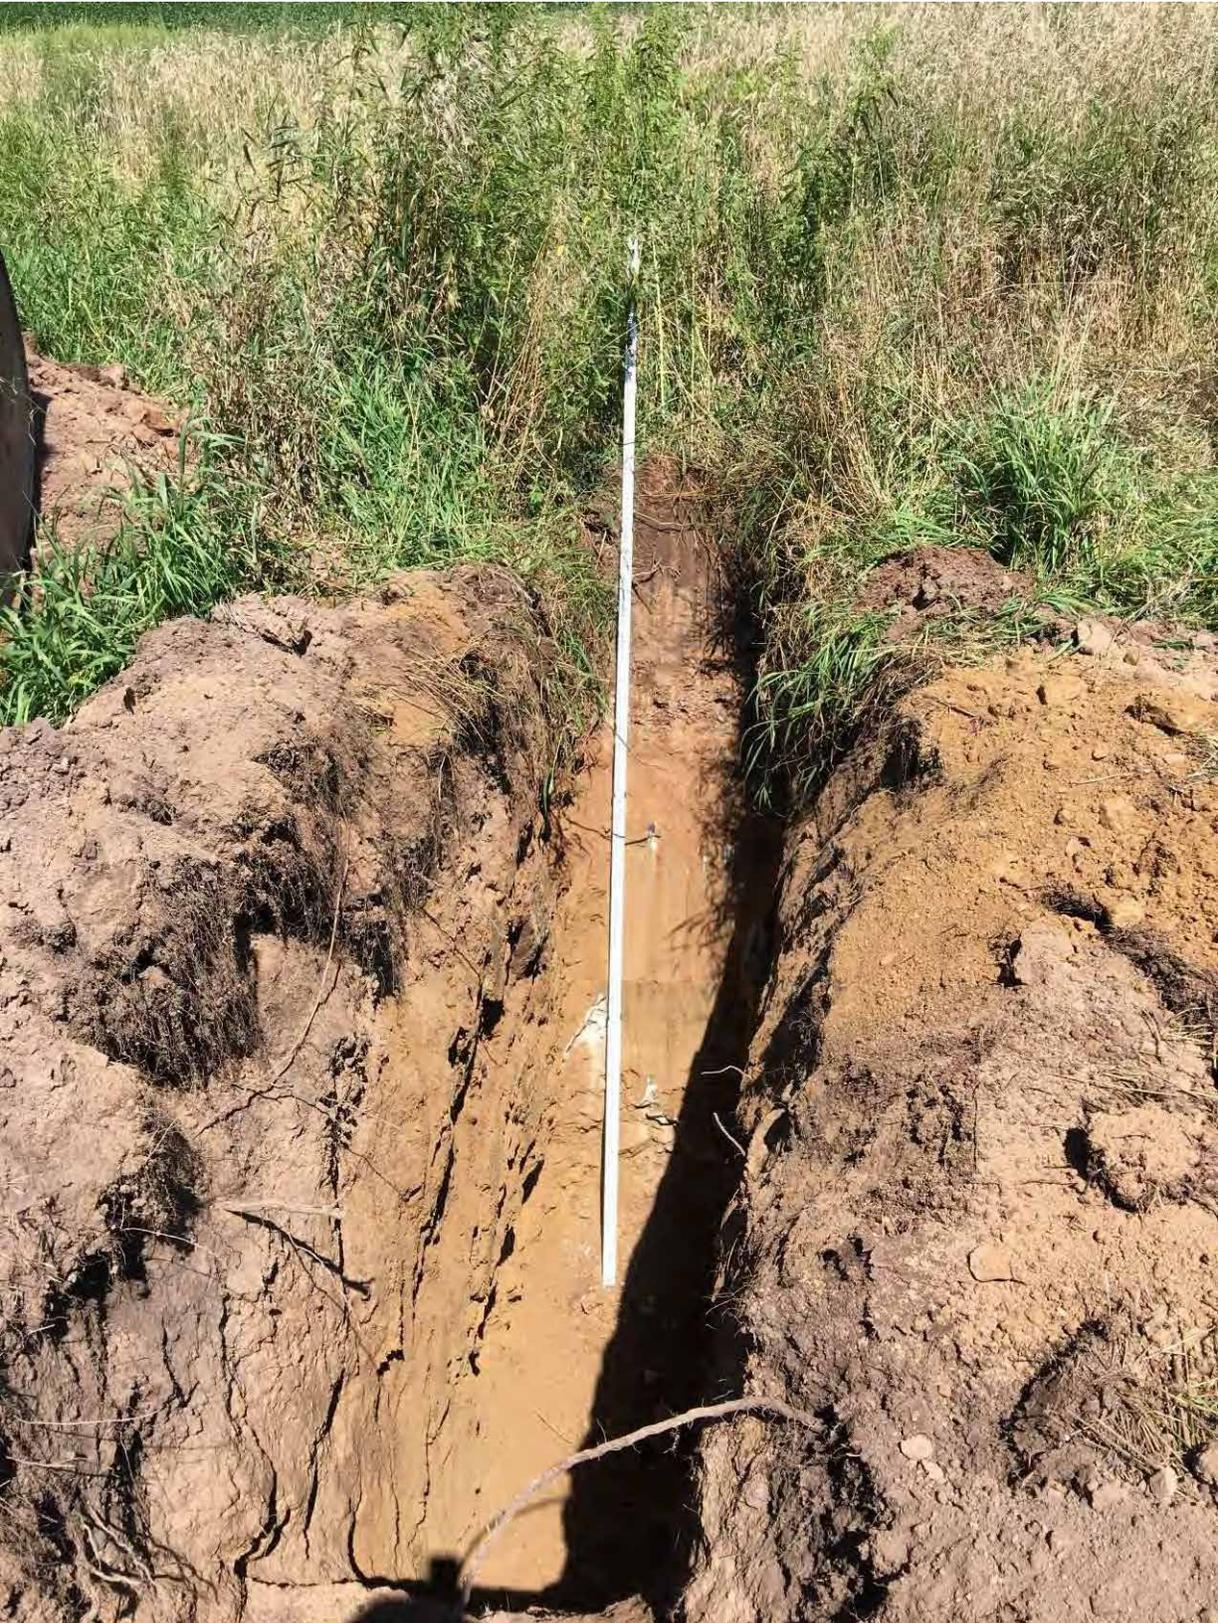
Photo No. 28 TP-04; maximum depth approximately 10 feet

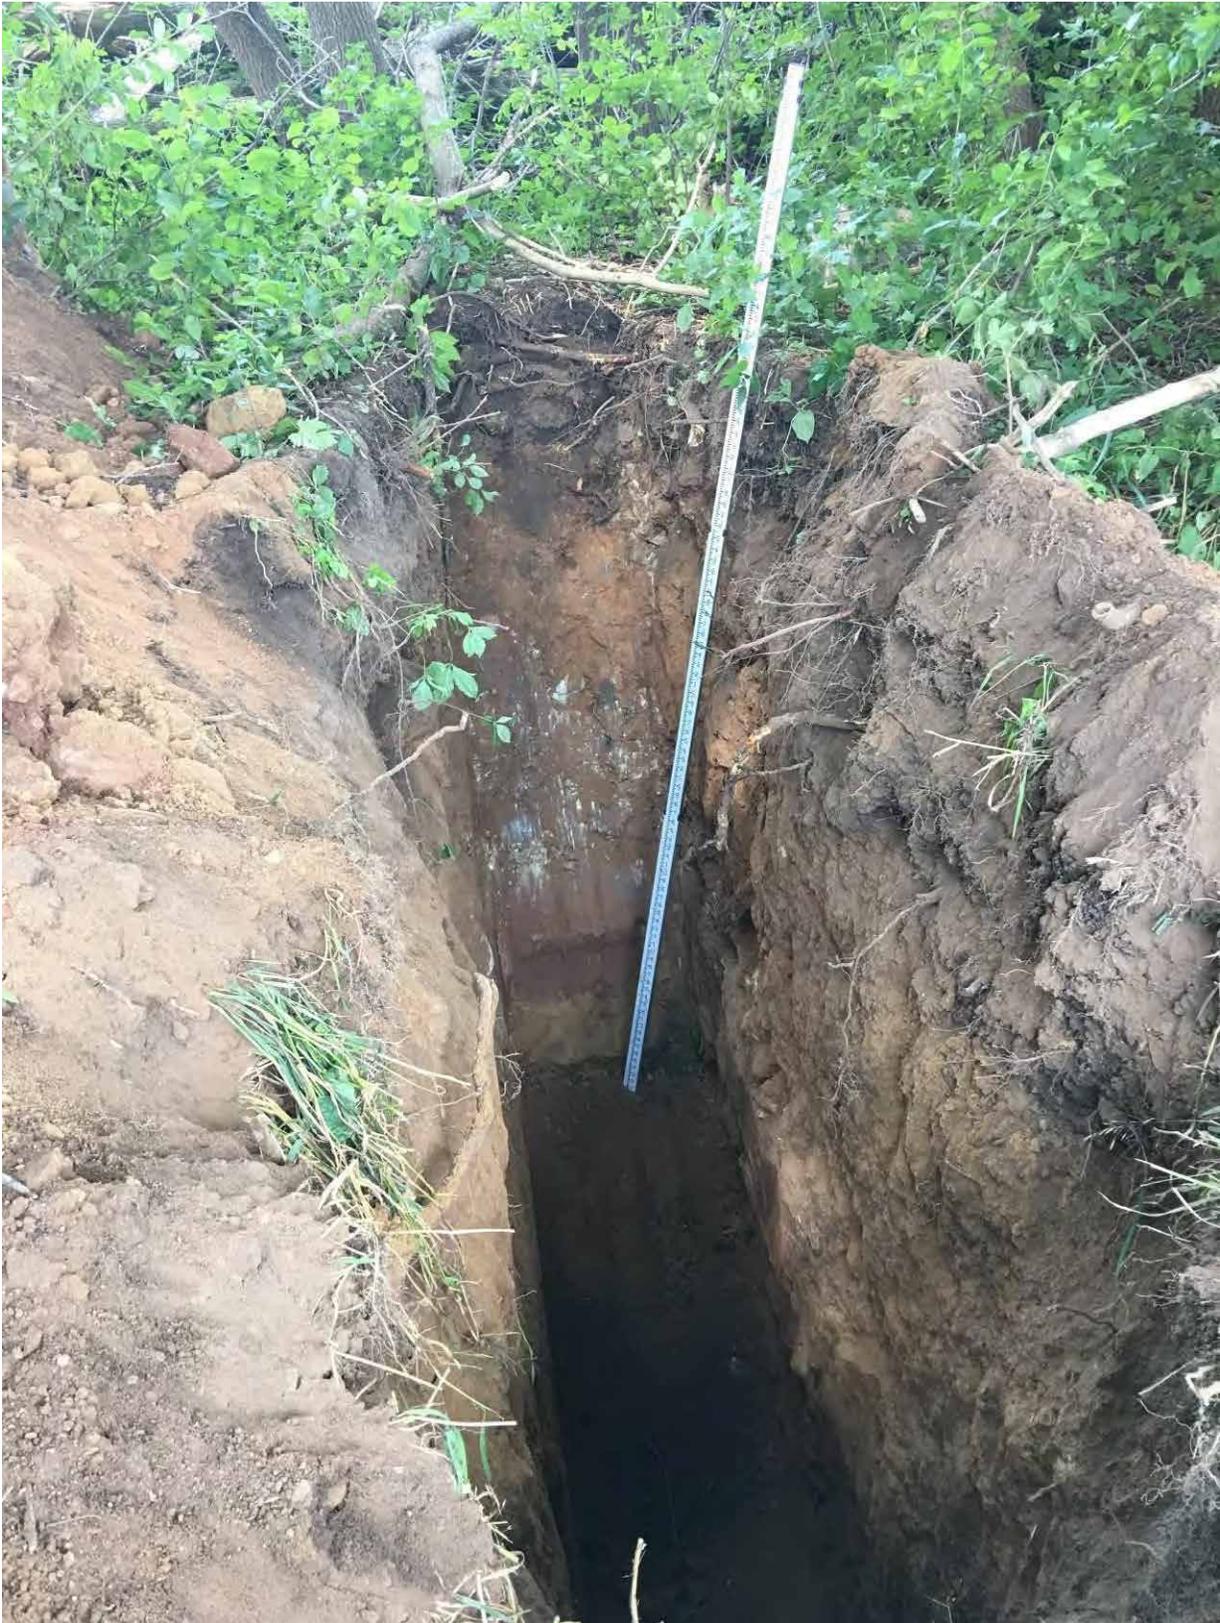
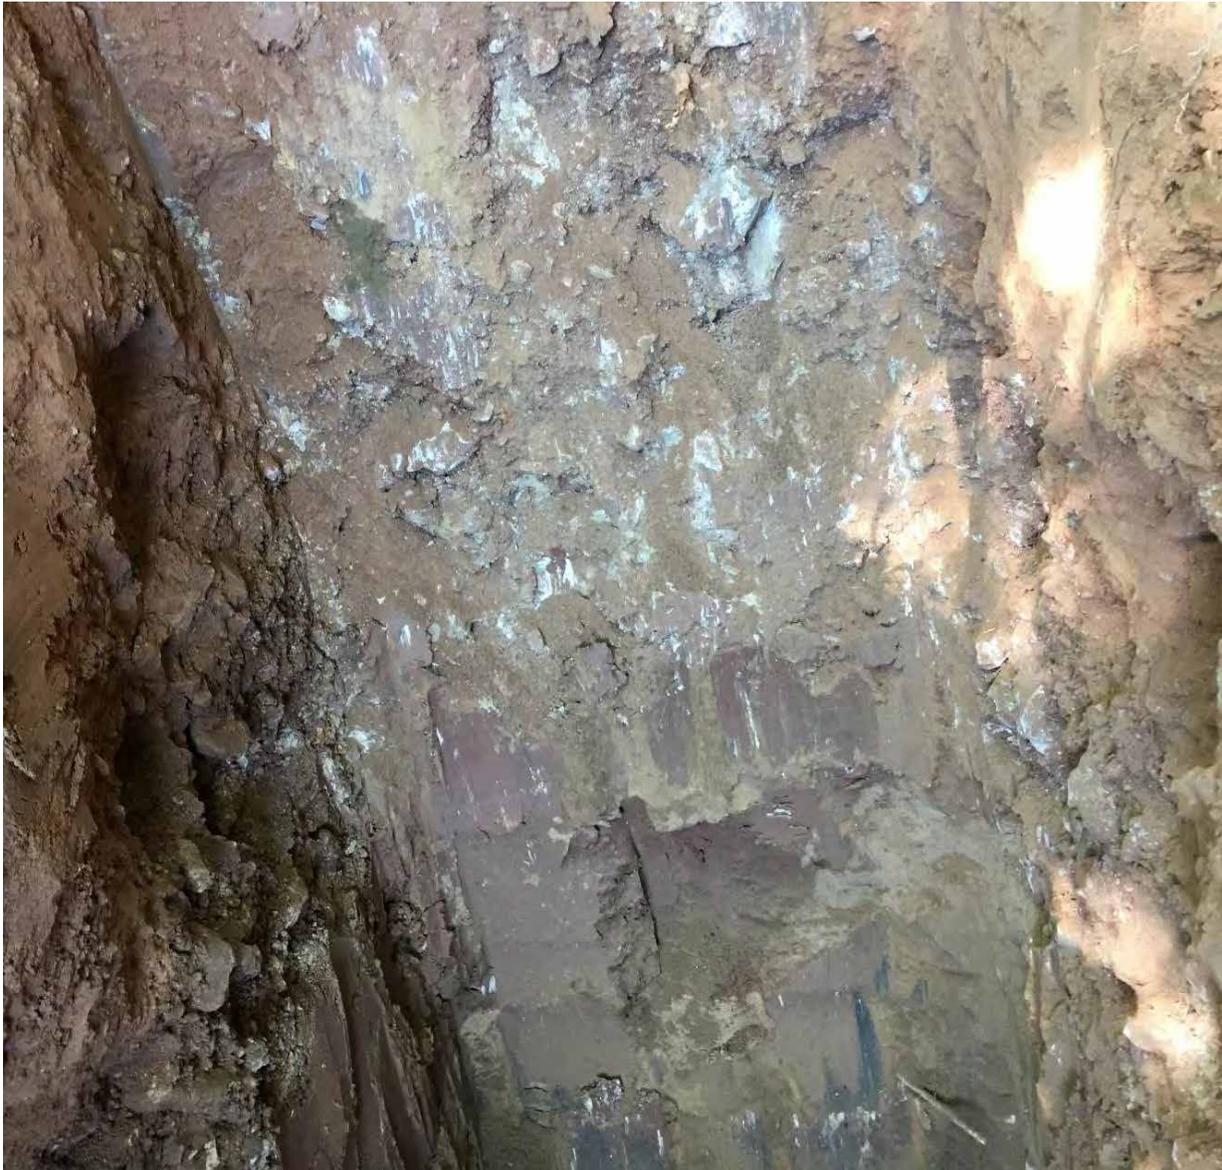
- TP-05: This is a location where cobbles appeared piled on the land surface and is reportedly one of the “swirlpool” locations. The test pit encountered a distinct column of poorly sorted, sub-rounded to sub-angular cobbles that extended to a depth of approximately 5 feet. This was underlain by a layer of reddish-brown clay loam (sandy, silty clay), which, in turn, was underlain by the yellow-brown silty very fine sand (see Photo No. 35). The dark grey silty loam topsoil followed the cobbles down to a depth of approximately 20 inches, as compared to a depth of 12 inches in the rest of the pit. A layer of reddish-brown clay loam was also encountered at roughly 9 feet, which was underlain by silty, very fine sand atop weathered dolostone, encountered at a depth of approximately 10.5 feet. The excavator could not remove the flagstone-sized pieces due to lack of reach and confines of the location.

Photo No. 35 TP-05; profile beneath rock pile

Photo No. 36 TP-05; profile beneath rock pile

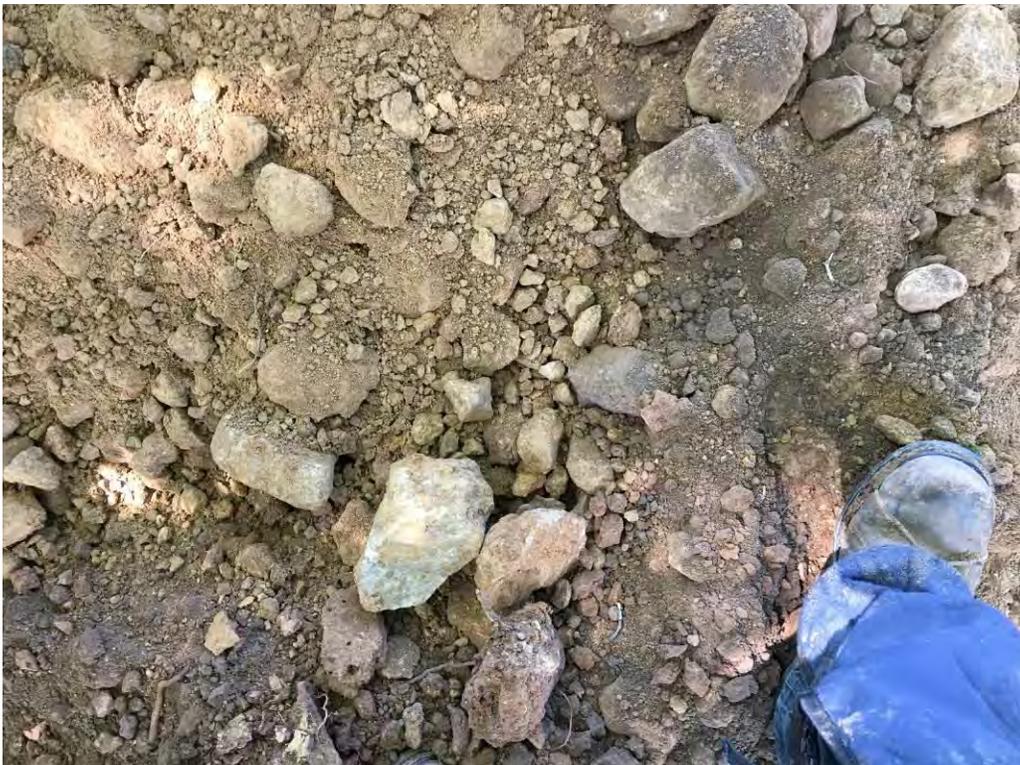
Photo No. 38 TP-05; excavated materials: fractured rock "blocks"

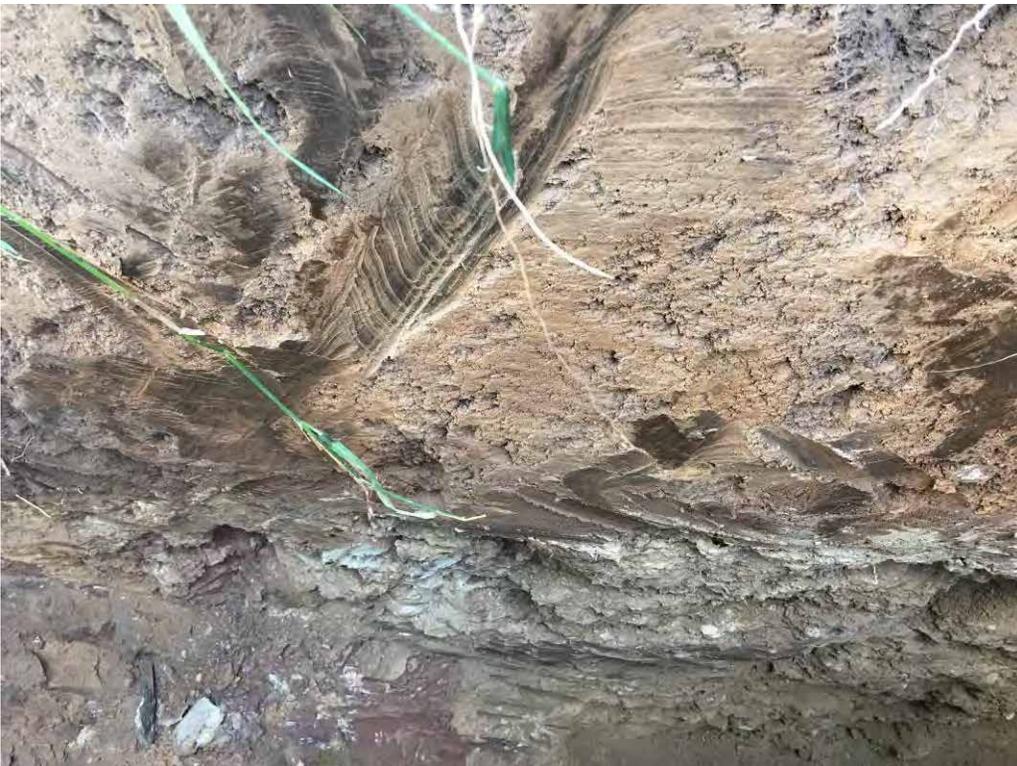
- TP-06: Topsoil was the same as elsewhere but to a depth of more than 30 inches. Beneath this was a horizon of higher clay content, followed by a “varved” layer inches thick composed of very thin lenses (a few millimeters thick) of alternating lighter and darker sediments. A layer of poorly sorted, sub-rounded to sub-angular gravel and cobble was present at about 6 feet; and this material graded into rock-contact sediments (i.e., gravelly, cobbly, silty, very fine sand) that extended another 4 feet into the subsurface. Weathered dolostone was encountered at about 11 feet, and flagstones were removed to about 12 feet.

Photo No. 43 TP-06; shallow sediments close-up
