Final Report
Town Hall Building,
Fire Station, &
Public Works Building
Facility Needs Study

Town of Greenville

December 7, 2010

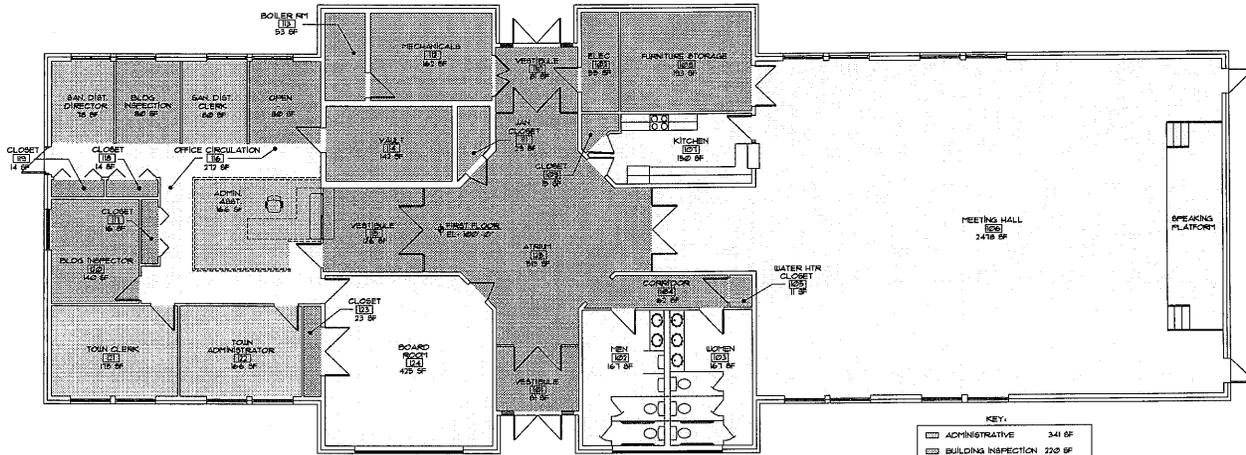
[Pattern]	ADMINISTRATIVE	341 SF
[Pattern]	BUILDING INSPECTION	220 SF
[Pattern]	SANITARY DISTRICT	376 SF
[Pattern]	SHARED	3659 SF
[Pattern]	STORAGE	402 SF
[Pattern]	MECHANICAL	314 SF
[Pattern]	PUBLIC CIRCULATION	833 SF

- The Building Inspection Department noted that there is not adequate space within the existing office to open up a large set of plan documents and hold a meeting with a builder or developer. Currently, meetings must occur either in the general open office of the Town Hall within earshot of the public and other administration staff. This is not conducive to the private conversations that often take place between the Inspector and the potential developers or builders.

- Appropriate file space is needed within the Inspection office. It was observed that many files are kept in cardboard boxes within the Inspection office. As more subdivisions are developed, there are more records that are being developed and a need exists to keep these in a fire resistive storage vault.
